# **The Morphodynamics of Motunau Beach and Management Implications**

A thesis  
submitted in partial fulfilment  
of the requirements for the Degree of  
Master of Science in Geography  
at the  
University of Canterbury

**Department of Geography  
University of Canterbury  
Christchurch, 2009**

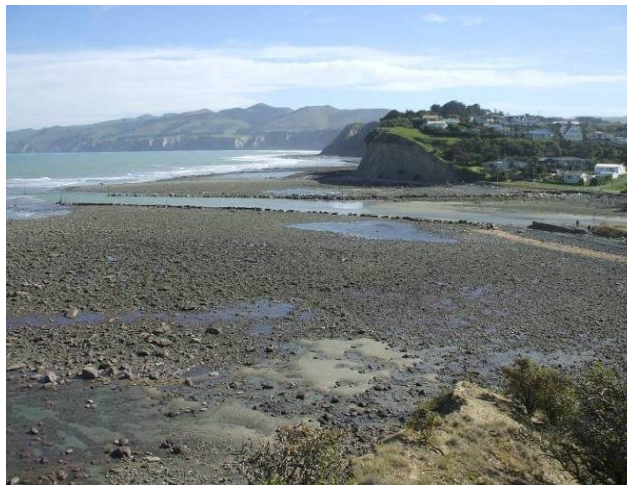
**Figure 1.2 View looking west towards Motunau River mouth, the eroding coastal cliffs, and Sandy Bay. Motunau Island to the left out of view. Note the variable sediment sizes; gravels and boulders, along with finer sands in the river channel (August, 2009).**

The dominant sediment sizes on Sandy Bay and around the river mouth consist of coarse grained sand with an average size of 0.13 mm or 2.94 phi (Ecan, 1995; Foster, 2008). This coarse grain sand is thought to be brought northwards by the net littoral drift from the south (Foster, 2008). The extent of sands and gravels along the promontory is potentially the result of seasonal variations in wave energy and tidal levels. This variation in sediment type and size is a good indicator of wave energy variation along the coastline (Figure 1.2).

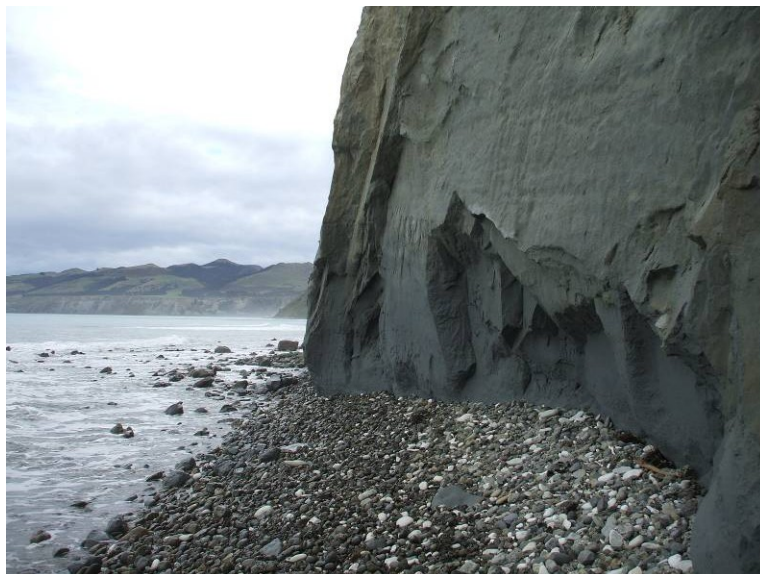
**Figure 2.2** A notch that has formed at the base of the cliffs at Motunau (photograph taken 2008).

The erosion of clay and sandstone cliffs in northern Boulonnais, France is closely related to shore platform dynamics (Pierre, 2006). The vertical erosion on the bedrock at the base of the cliffs leads to cliff collapse. The speed of this basal lowering is dependent on the material present at the base of the cliffs which can act as a buffer against wave attack.

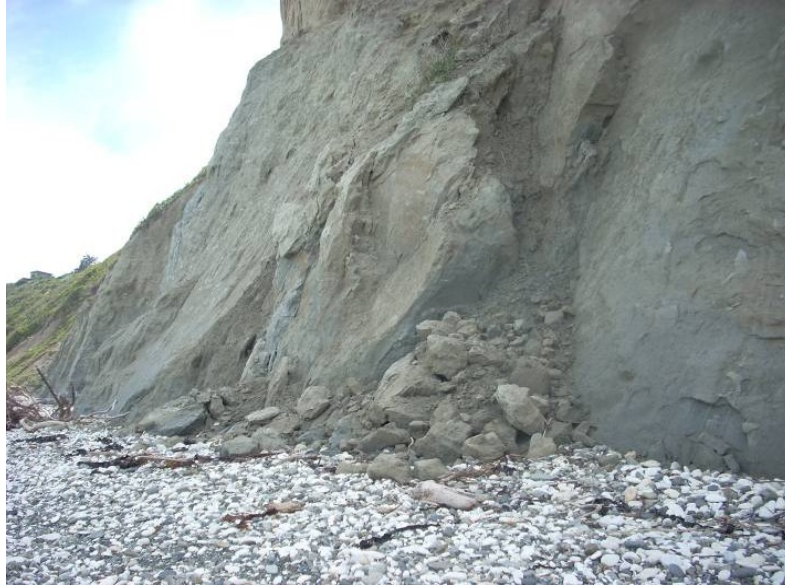
**Figure 2.3 A collapse has occurred as a result of the cliff profile becoming over steepened and less stable (photograph taken 2009).**

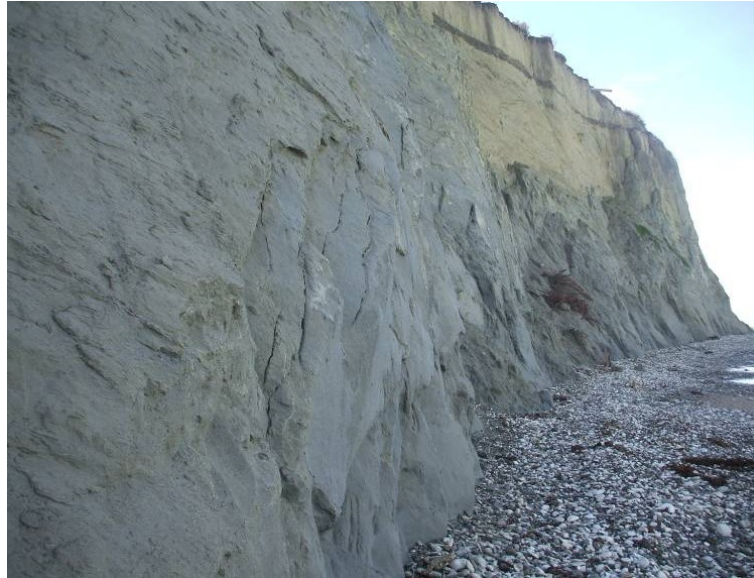
**Figure 2.4 Bare rock face at the base of the cliff exists due to constant removal of material by wave action (photograph taken 2009).**

After prolonged periods of weathering a cliff will slump and slide to form a slope at the base of the cliff. This temporary slope provides support for the over steepened cliff. When a high rate of debris removal exists a bare rock face at a constant angle will be maintained (Figure 2.4). If the rate of cliff collapse exceeds the removal of sediment by wave action then the material accumulates into a talus slope (Figure 2.5) (Masselink and Hughes, 2003). As illustrated by Figure 2.6, constant wave attack can remove the support from the base of the cliff transporting the eroded material downdrift, exposing the cliff toe again to repeat the process (Lee, 2008).

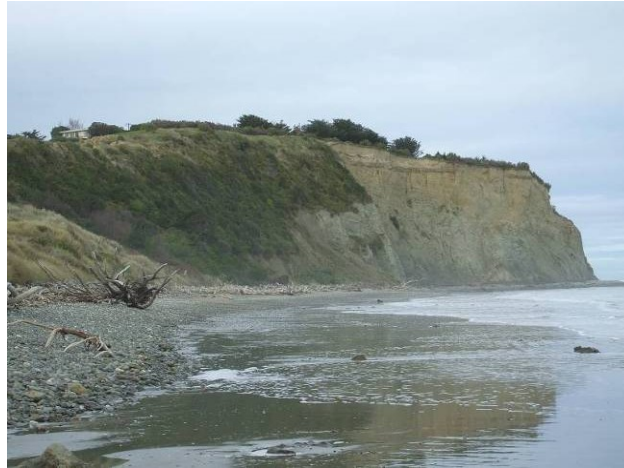
**Figure 2.8 Looking east towards the coastal cliffs at Motunau Beach. Note the Sand beach system in the foreground which is attached to the western base of the cliffs (photograph taken 2009).**

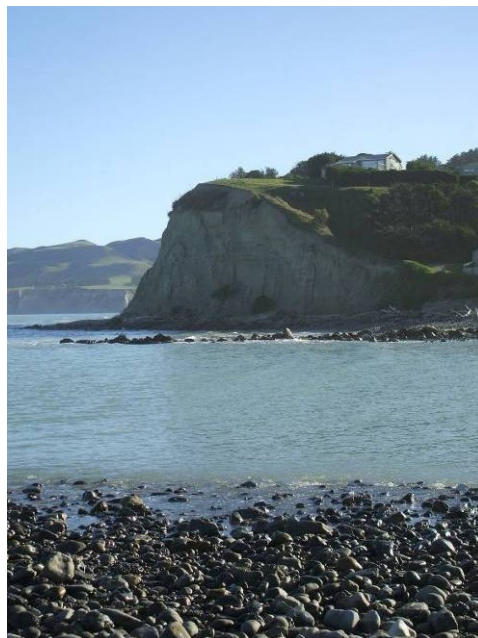
**Figure 2.9 Looking southwest towards the cliffs. Motunau River mouth in the foreground (photograph taken 2009).**

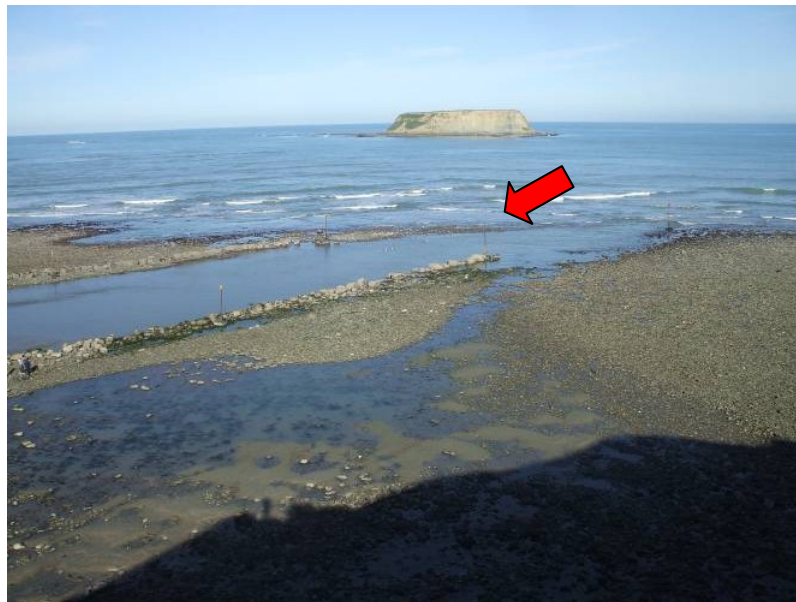
**Figure 2.12 Photograph taken from the river mouth looking south towards Motunau Island. In the foreground the Motunau River mouth bar is semi exposed (July 2009).**

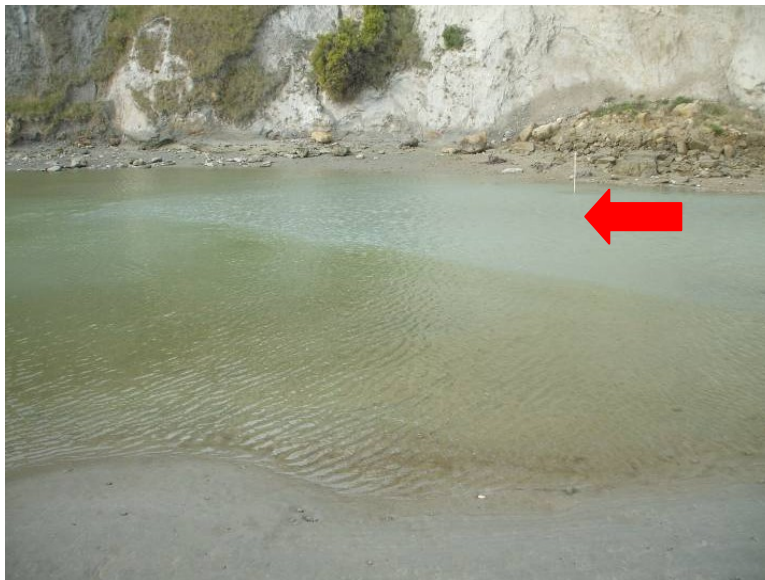
**Figure 2.13 A plume of sediment drifts upstream on the flood tide in the lower reaches of the Motunau River (photograph taken 2008).**

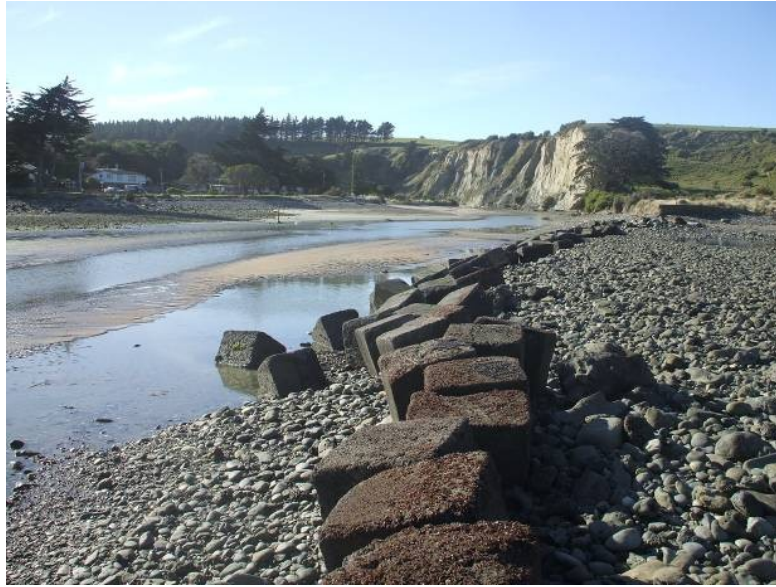
**Figure 2.15 Subsidence of precast concrete channel guides. Note the elevation difference between the river channel bed and the beach to the right. Photograph taken 26th July 2009 looking upstream from the mouth of the Motunau River.**

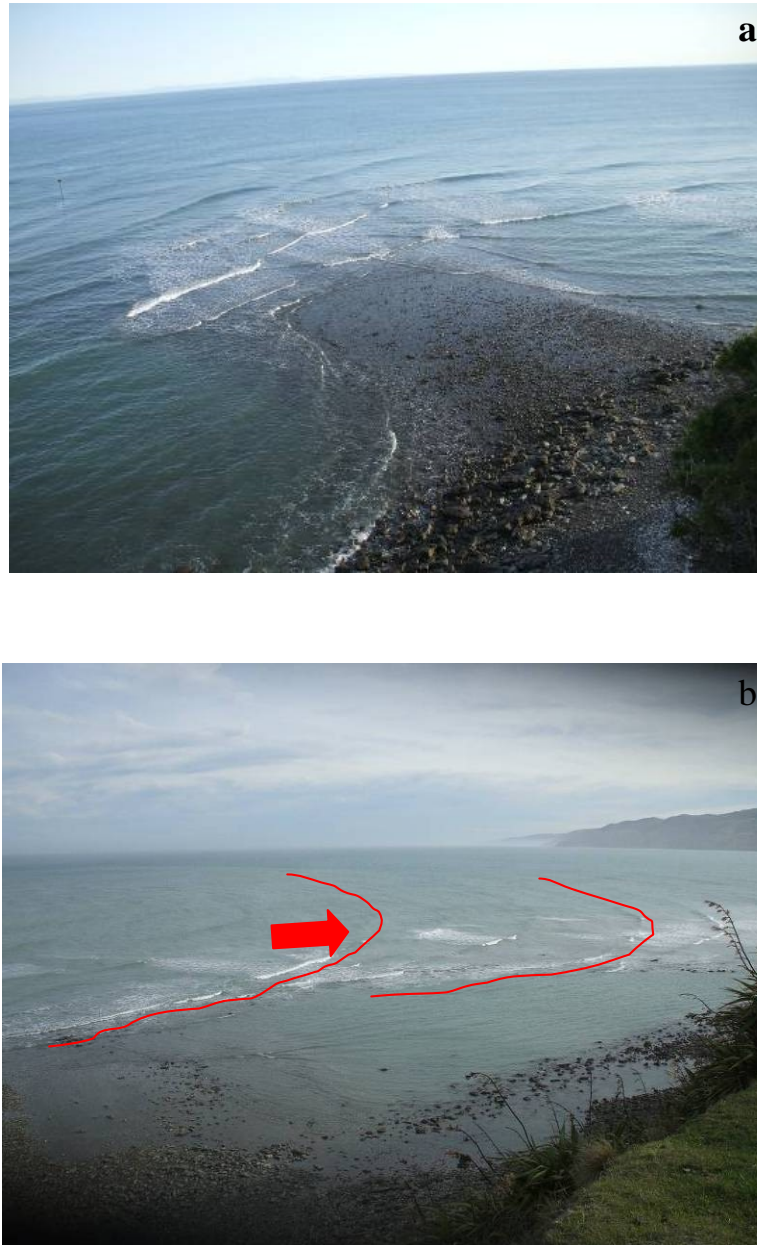
**Figure 2.18 a) Wave refraction at Motunau Beach on the rock platform at the base of the coastal cliffs (September, 2009). b) Wave refraction into Sandy Bay (August, 2009).**

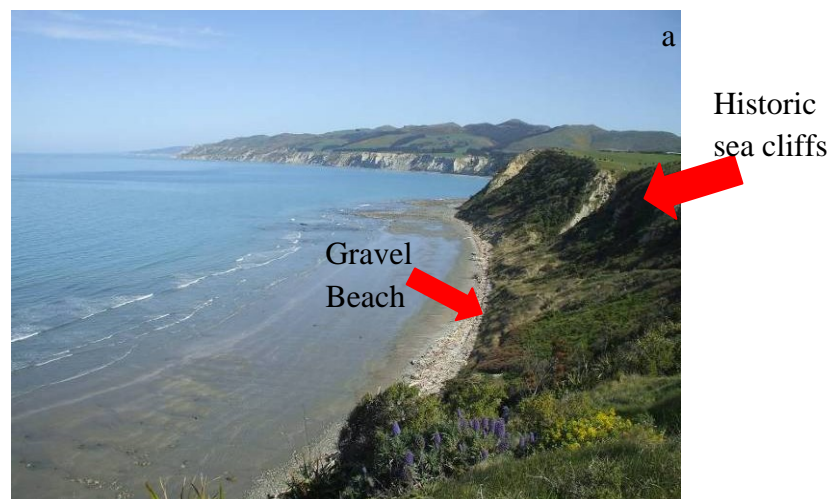
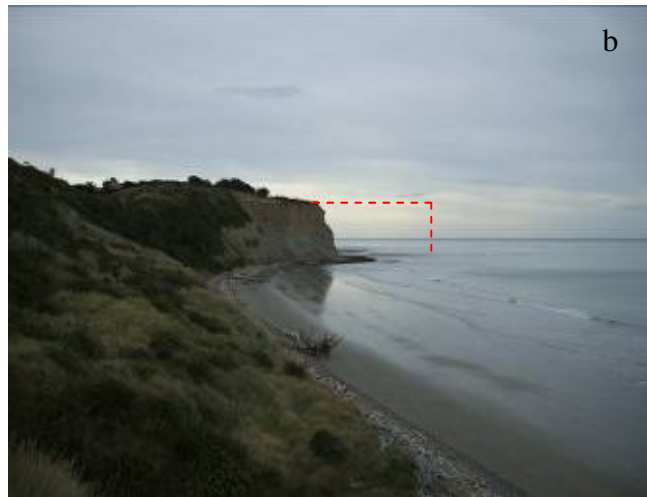
**Figure 3.7 a) Sandy Bay photograph looking west (17<sup>th</sup> August 09). b) View looking east from Sandy Bay. Note the high tide level at the base of the sand dune system in the left of the photograph (April 09). Erosion of the cliffs has reduced the bays ability to accumulate sediments. The hashed line represents the historical extent of the cliff line.**

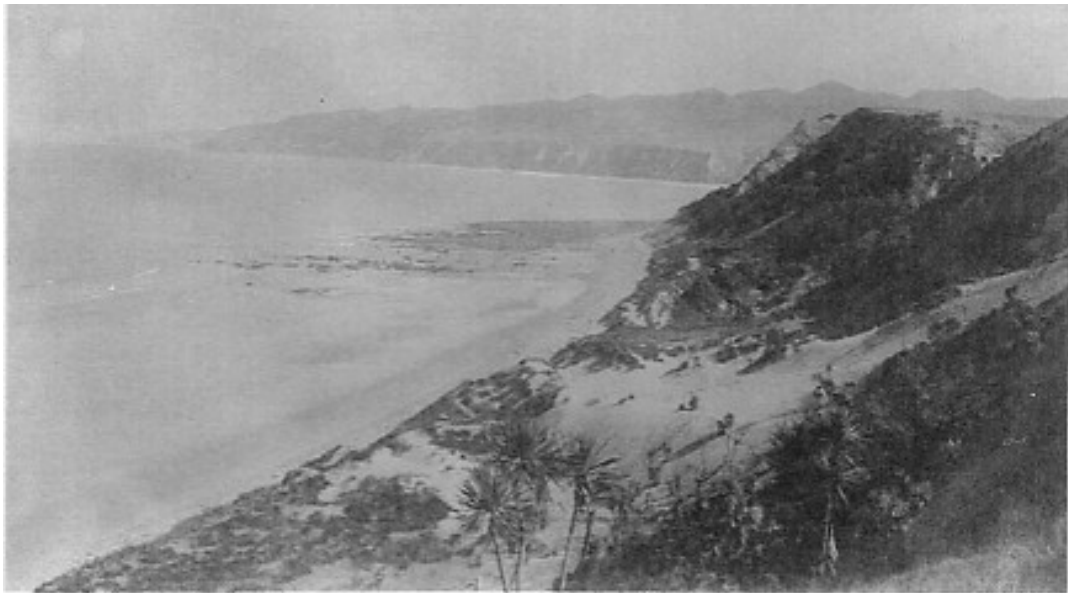
**Figure 3.8 View looking southwest along Sandy Bay. Note the extent of the sand dune system prior to the increased rate of erosion in the 1950s (Photograph taken late 1930s).**

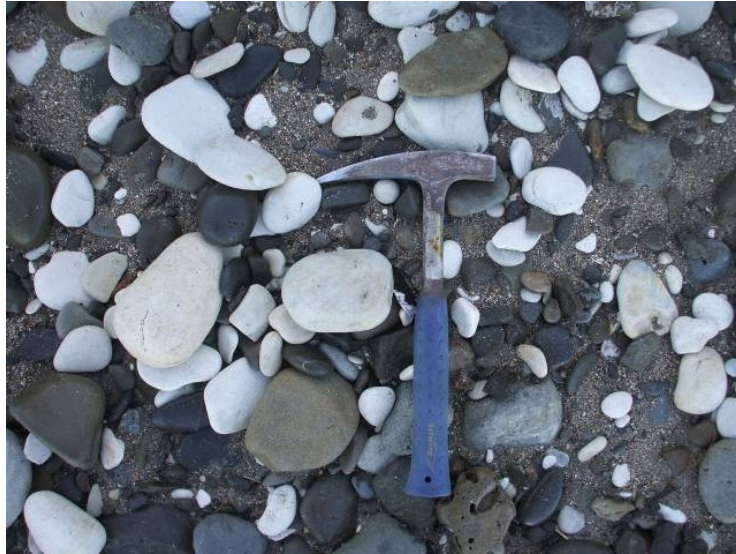
**Figure 3.9 Size of material on gravel beach along the length of Sandy Bay. Note the mixed sediments in terms of size range and lithologies of greywacke and limestone (Photograph taken 26<sup>th</sup> July 09).**

At its widest point the coarse unconsolidated gravel beach is approximately 14 m wide nearest to the eroding cliffs. It progressively thins further away from the eastern end of the beach to an approximate width of 2 m (Figure 3.9).

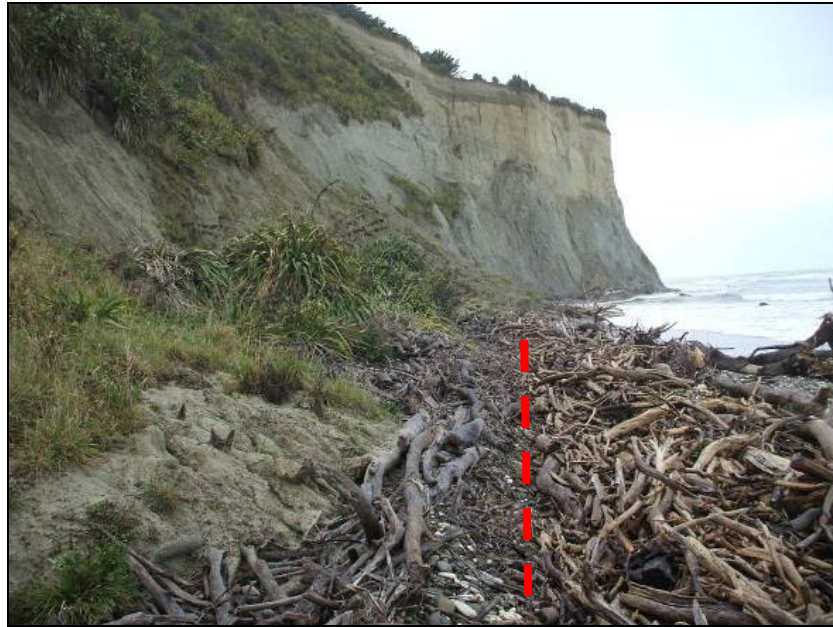
**Figure 3.10 Photograph looking east towards eroding coastal cliffs from Sandy Bay. Note the two distinguishable layers of driftwood indicating previous storm events (Photograph taken 29<sup>th</sup> June 09).**

Atop this gravel layer there is presently a layer of tightly packed driftwood and debris ranging from large tree stumps, to 5 m lengths of timber with thicknesses of around 120 mm. The wood is willow indicating that it has potentially originated from the Motunau River catchment and has been scoured from the catchment during large river flows. The last significant flow was in August 2008. Unfortunately flow recordings were not measured as gauges were destroyed. Looking along Sandy Bay the distinct layers in driftwood, which indicate past high river flow and sea level events, are clearly visible (Figure 3.10). The orientation of the river mouth, which faces a southerly direction, suggests high river flows may expel the debris towards Sandy Bay. Wave action then brings the debris onshore where it is reworked and sorted by tidal processes. The gravel beach deposit and debris layer lies at the base of the eroding dune system. The dune system is characterised by a consistent erosional scarp along the length of the beach. The reflective layer of stone and wood protects the erosional scarp allowing the buildup of slump debris from the dunes. It appears the coarse deposits are acting as a naturally occurring wave-trip wall. Erosion appears to be most evident in the areas of Sandy Bay that are not protected by gravel and drift wood, for example, the western end of the beach.

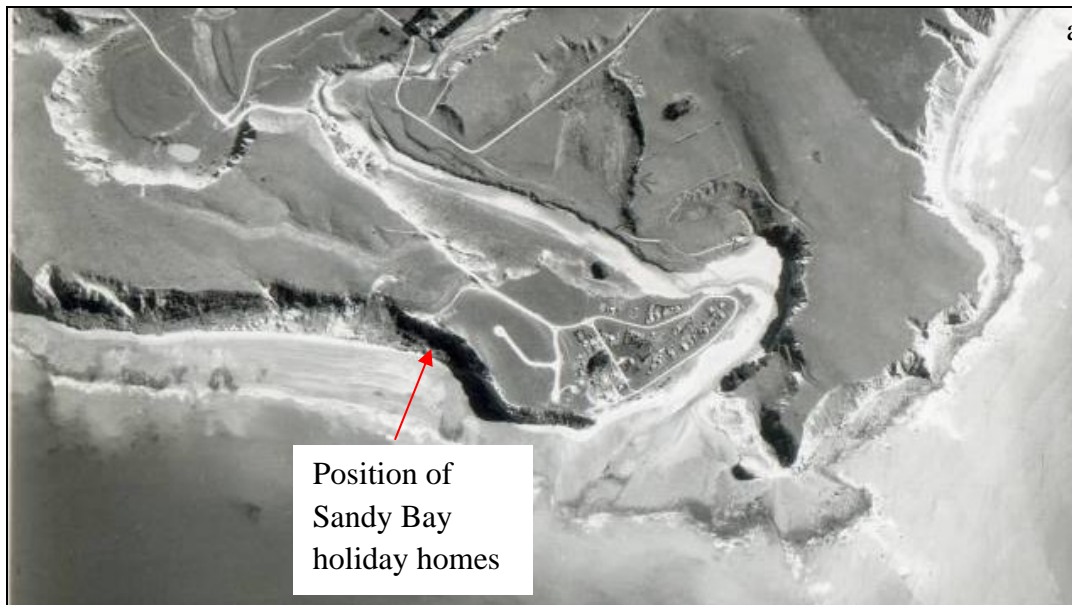
**Figure 3.13 a) Vertical aerial photograph taken on the 10<sup>th</sup> October 1950. This photograph highlights how un-established the Motunau Township is at this time. The residential development atop the eroding coastal cliffs, in the centre of the image has not yet been built. This photo was taken at a 1:18000 scale at approximately 8.38 am and the tide height was -0.93 m. b) Picture taken looking east from Sandy Bay in the early 1950s towards the eroding coastal cliffs prior to erosion problem. Note the position of the high tide level and presence of a foredune (sourced from Simon Foster, local resident, 2009).**

The period following 1950 is associated with the progressive erosion of the shoreline and loss of beach width. It is interesting to note that prior to the 1950s there was very little by way of a settlement in Motunau Beach (Figure 3.13). Since then, however, there has been a progressive development of the area, not only with holiday homes but also permanent housing. One explanation for this increased rate of erosion could lie in the fact it only began to be recognized post 1950s. There were more people occupying the area and living there permanently and so physical changes were more readily noticed. Supported by previous examples from Barrell (1989), the current erosion taking place at Motunau Beach is not a contemporary issue. It appears it is part of a larger-scale of long-term coastal change. This coastal change has been related to the retreat and advance of global ocean levels. The current shoreline morphology indicates that the erosion at Motunau Beach has been an ongoing process, as can be seen by the position of Motunau island, over the last 5,000 years. The extent and rate of sea level rise has occurred at temporal and spatial variations which mean that there has been a series of sporadic periods of sediment erosion and sediment accretion around the promontory.

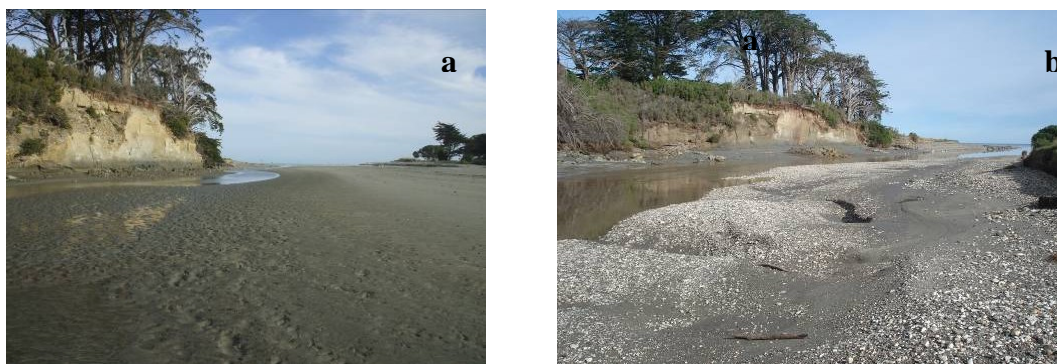
**Figure 4.4 a) Pre flood 6<sup>th</sup> June 2008. b) Post flood 5<sup>th</sup> August 2008. Photographs taken approximately 200 m upstream of the Motunau River mouth.**

Figure 4.4 shows that after a large river flood the sand material deposited in the lower reaches of the river channel during high tide has been scoured. This has lowered the base level of the river channel exposing the coarser gravels beneath. This also has negative effects for navigation safety within the channel. Figure 4.5 shows the gravel bar that is exposed after large storm events.

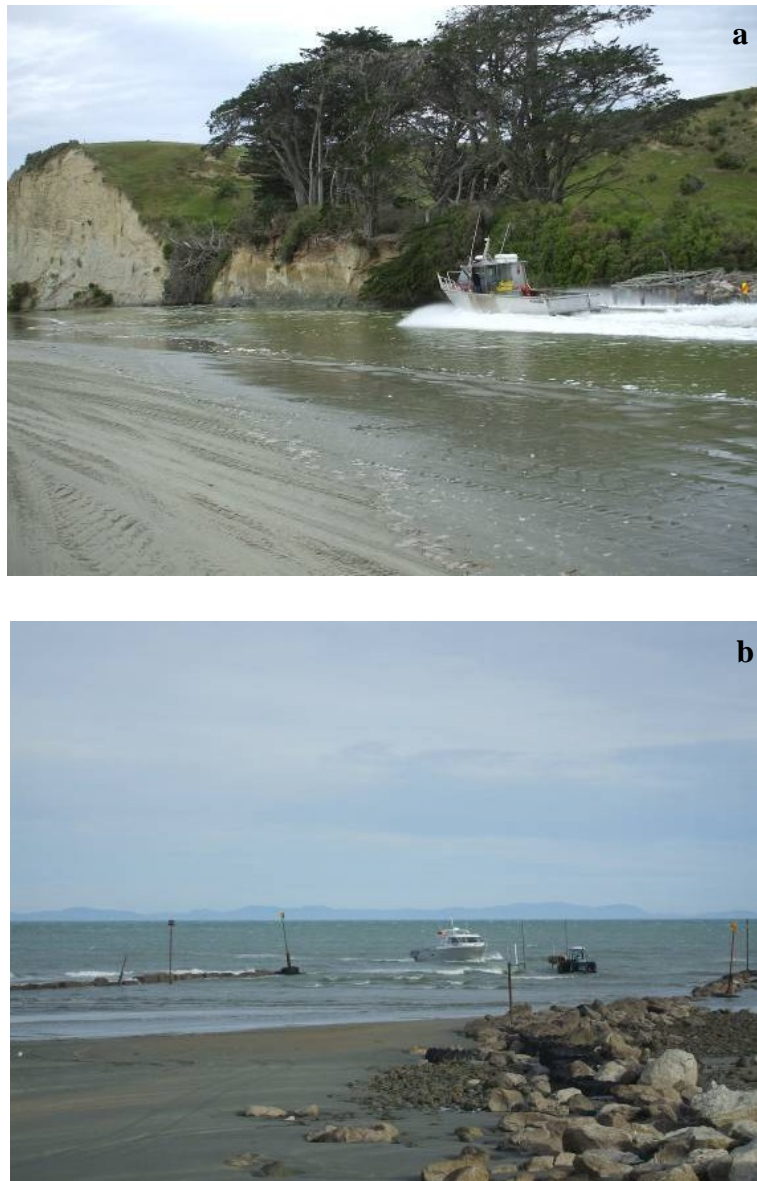
**Figure 4.6 a) A local fishing vessel heading upstream of the Motunau River mouth towards the loading ramps during high tide (photograph taken 2008). During times of low river flow water levels in the river cannot support the passage of fishing vessels. b) During these times boats must be launched and then recollected at the river mouth. As a result, this poses an obvious danger to vessels (Photograph taken 2008).**

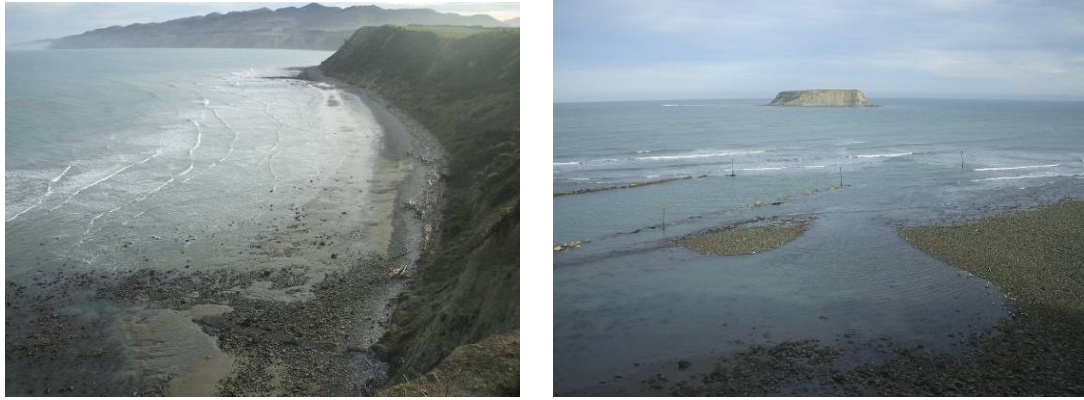
**Figure 4.8 a) Looking southwest along Sandy Bay (August 2009). Note the refraction of low energy waves into the bay, and the pronounced rock platforms at either end of the bay. b) Motunau Island 1 km south is influential in dissipating and redistributing wave energy in the nearshore zone (July 2009).**

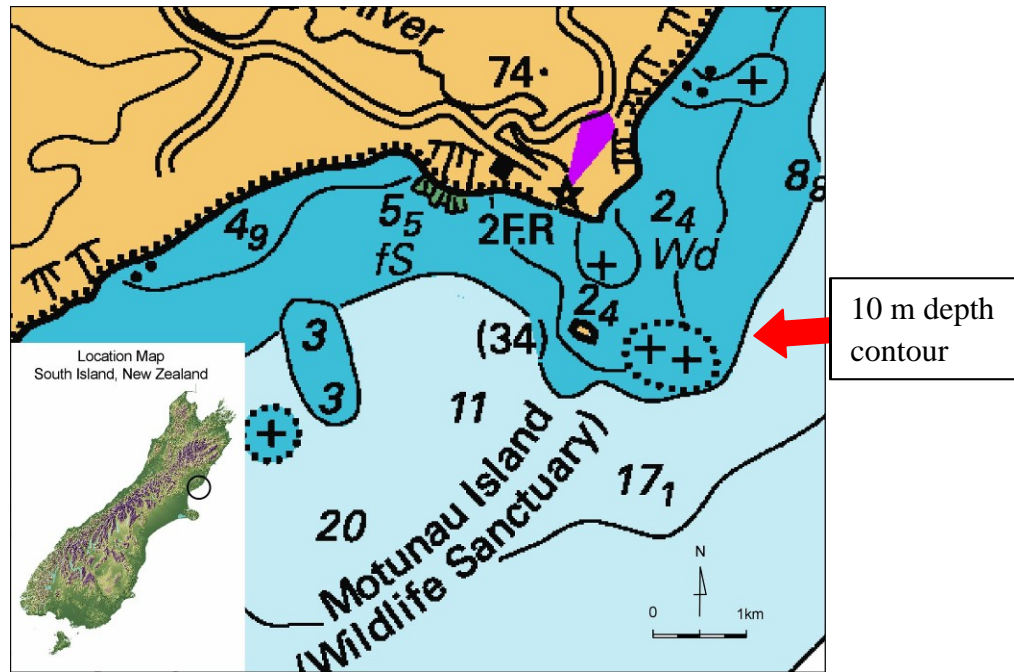
**Figure 4.9** Hydrographic chart of the Motunau Beach coastline, depths are in meters. Modified from the 1:200,000 scale chart, available from [www.LINZ.co.nz](http://www.LINZ.co.nz), 2009.

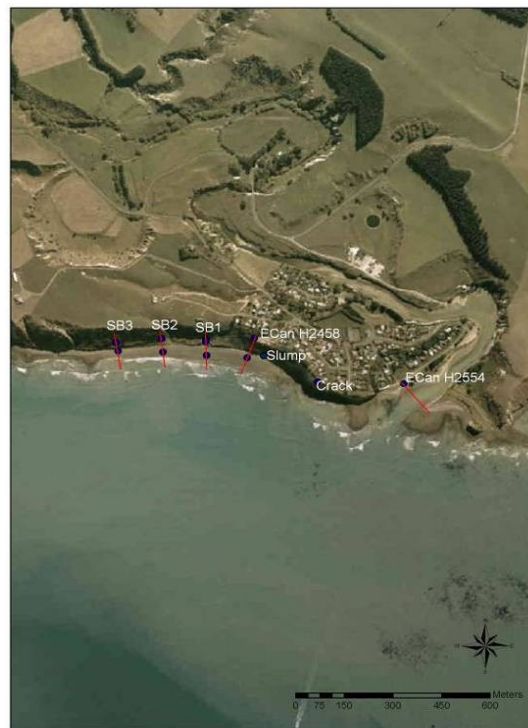
**Figure 5.1** Location of the shore profiles used for the July to September study period. Aerial photograph sourced from [www.linz.govt.nz](http://www.linz.govt.nz).

The previous chapter gave an in-depth look at the wave environment around Motunau Beach. This is important for the analysis of sediment transport directions and identifying potential areas where local residents might expect wave focusing or shadowing. Chapter Five employs GIS techniques to examine changes that have occurred in Motunau since the 1950s. These techniques have been used to measure fluctuations in the level of sediment along the beach and include; the use of aerial photograph comparisons to compare long-term change, along with shoreline profiles on Sandy Bay. Figure 5.1 outlines the locations of the five shoreline profiles that were measured at two week intervals during the study period. This figure indicates the location of the debris slump and cliff tension crack. These two features were regularly measured in order to gauge and quantify a rate of change. Appendix D contains coordinates for their positions.

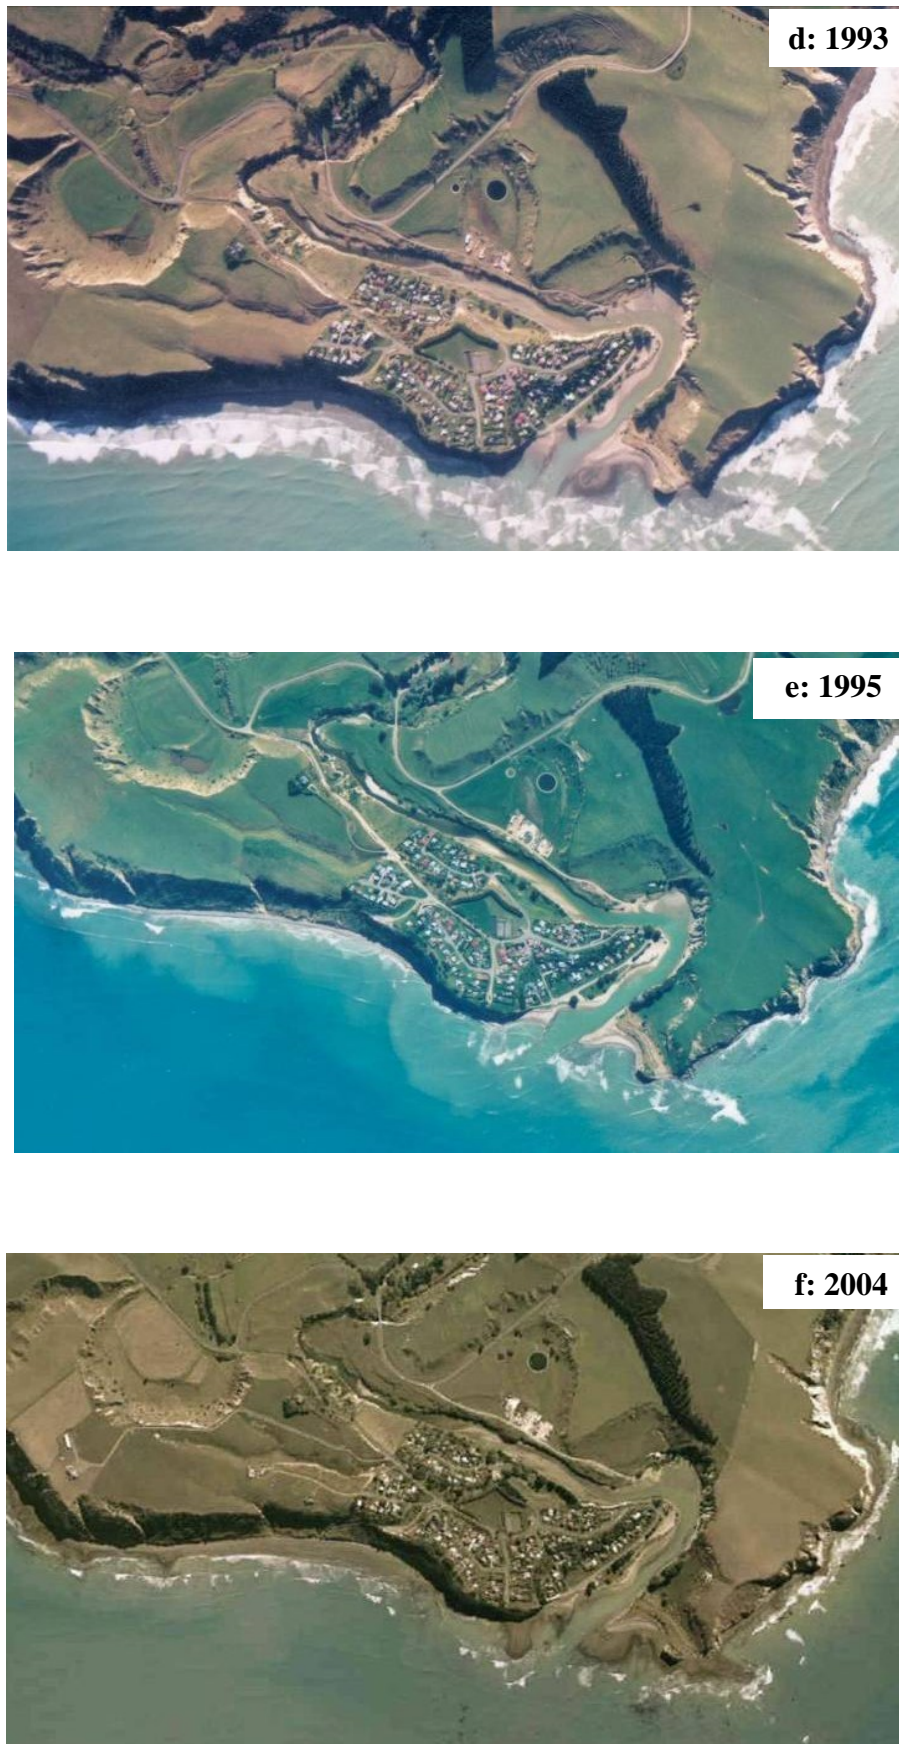
Figure 5.2 Aerial view of the Motunau Beach study site from 1950 to 2004. Aerial images 1968 to 1995 sourced from Andrew Woodward, ECan archives, 2009.

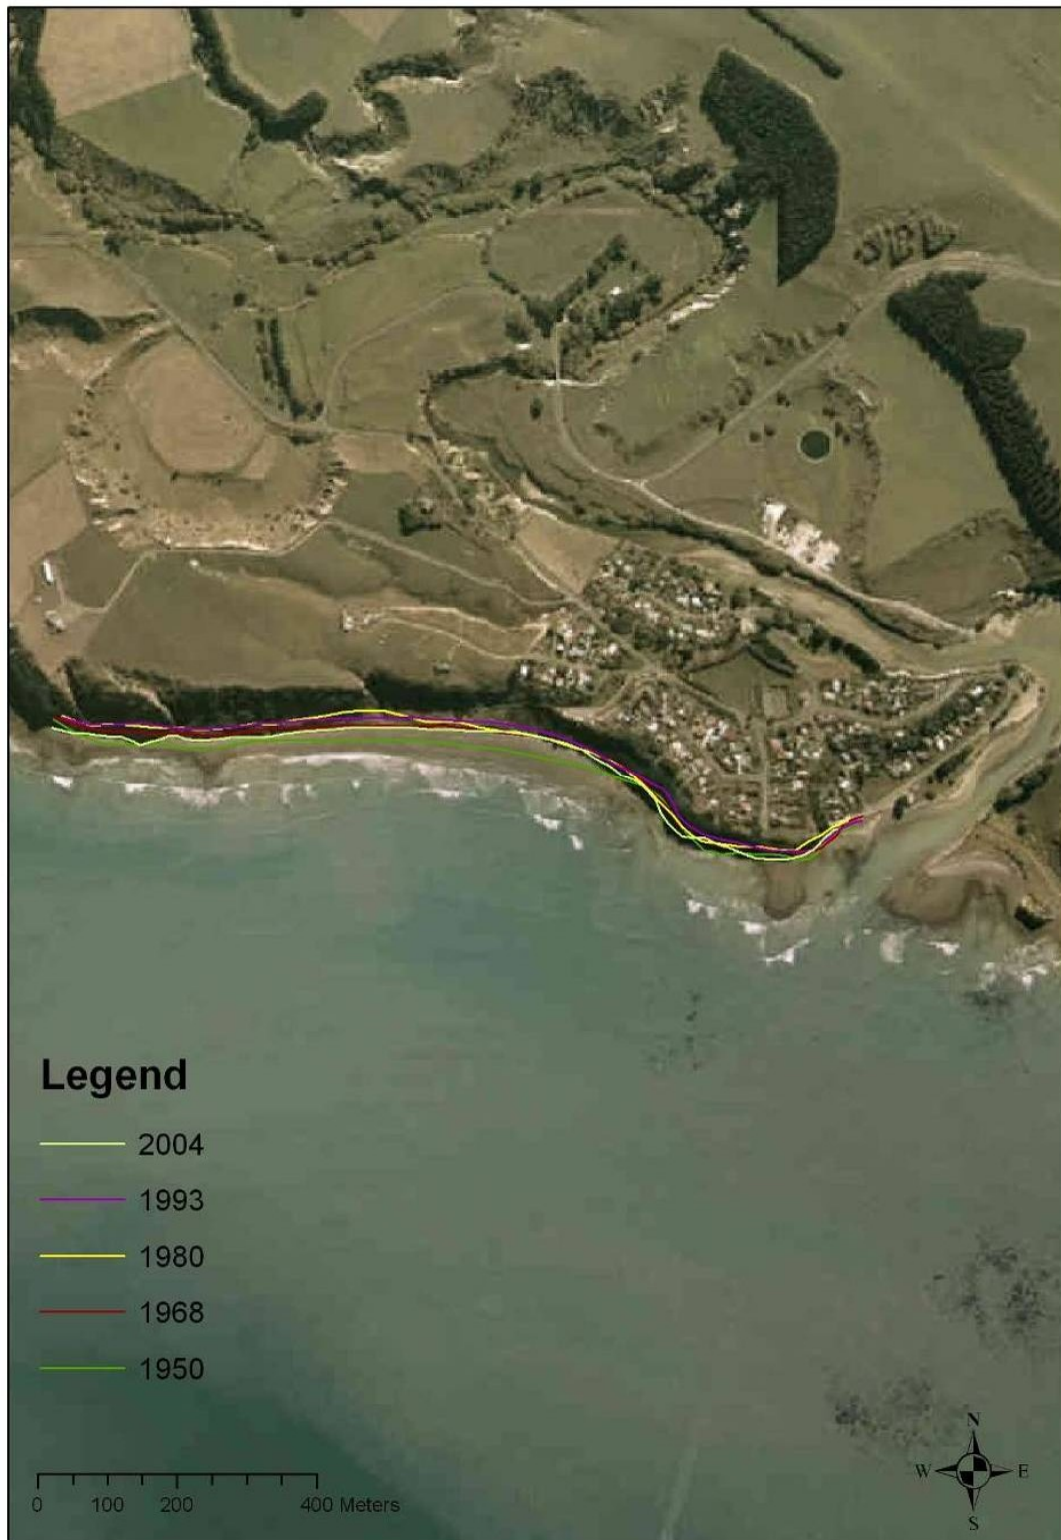
**Figure 5.4** Historical shoreline positions of Motunau Beach 1950 to 2004 determined using aerial photograph analysis and superimposed on the 2004 photograph. Aerial image sourced from [www.linz.govt.nz](http://www.linz.govt.nz).

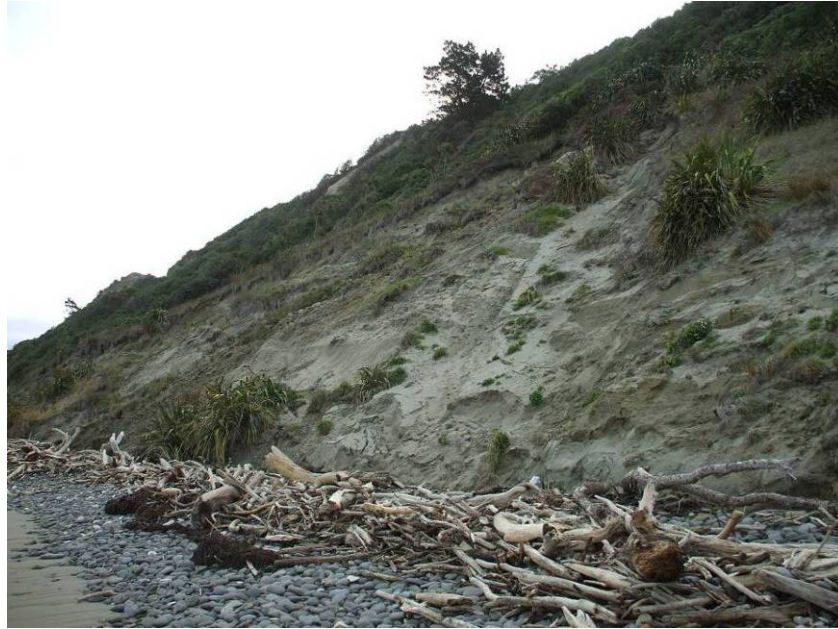
**Figure 5.8 Slope of erosional scarp at base of eroding historical dune system towards the western end of Sandy Bay. Note the thin layer of drift wood and the thin gravel beach. Photograph taken early July 2009.**

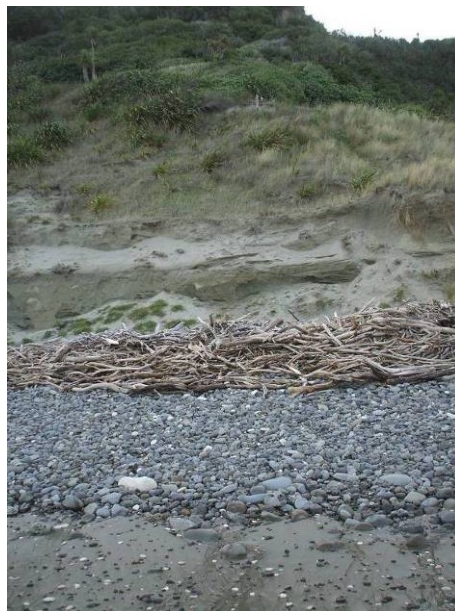
Figure 5.11 Upper beach profile at SB2. Photograph taken late June 2009.

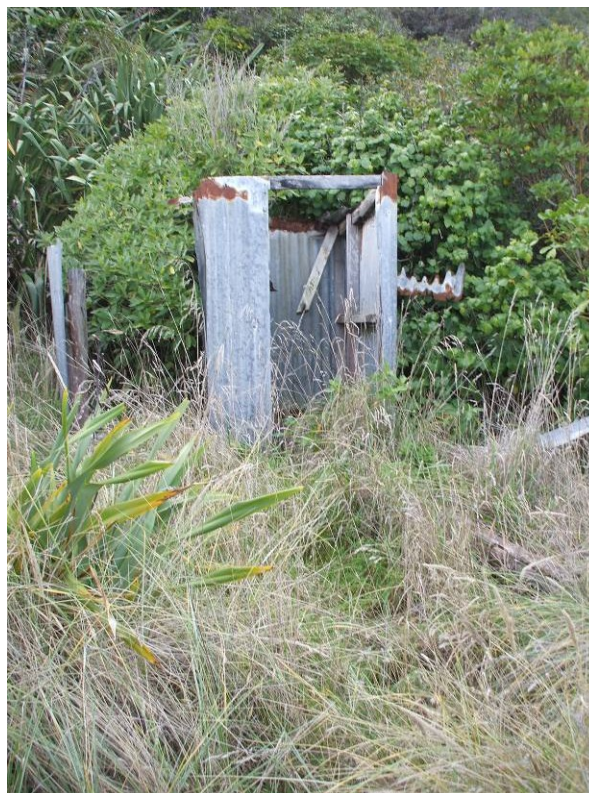
Figure 5.14 Old changing shed in the dunes at profile SB1 situated 10 m above MSL. Photograph taken July 2009.

The Sandy Bay profile one (SB1) was also characterized by fluctuations in sediment levels in the range of 0.2 m to 0.5 m (Figure 5.12). The low beach gradient supports the dissipation of wave energy. There appeared to be a level of accretion by approximately 0.2 m between the surveys 30<sup>th</sup> June to the 15<sup>th</sup> July. This was followed by an erosional event. From the 27<sup>th</sup> August there appeared to be a relatively steady state of erosion and accretion up until the end of September. The left of the profile represents the erosional scarp of the historical dune system. This slope is more vegetated in comparison to the previous profiles. The upper limit has had a high level of human interference in the past due to presence of an old swimming changing shed (Figure 5.14).

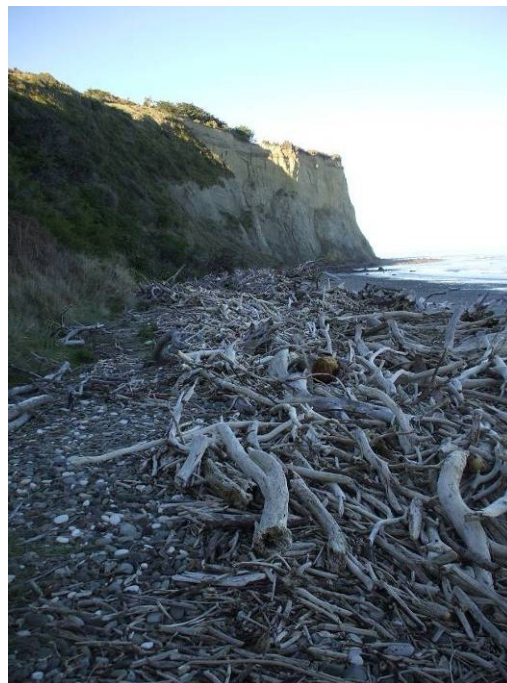
Figure 5.17 Example of the beach slope towards the eastern end of Sandy Bay at ECan profile H2458. Note the width of the gravel deposit and driftwood deposit. Photograph taken late June 2009.

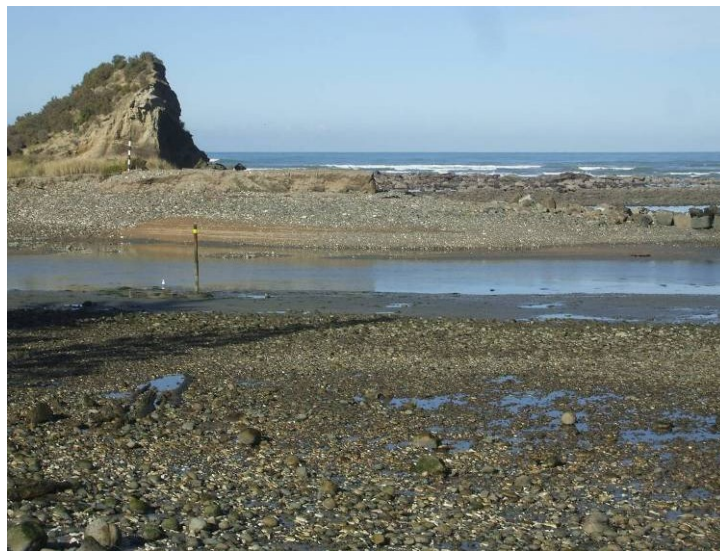
Figure 5.20 Example of the river bed morphology at profile ECan H2554. Note the coarser material at the edges of the channel with finer sands in the middle. Photograph taken 26th July 2009.

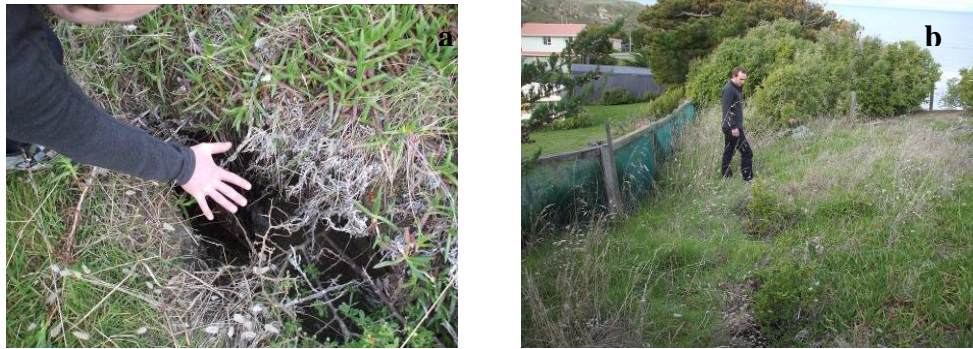
**Figure 5.25 a) the crack atop the cliffs, b) notice a property boundary fence to the left. Photograph taken prior to study period in late June 2009.**

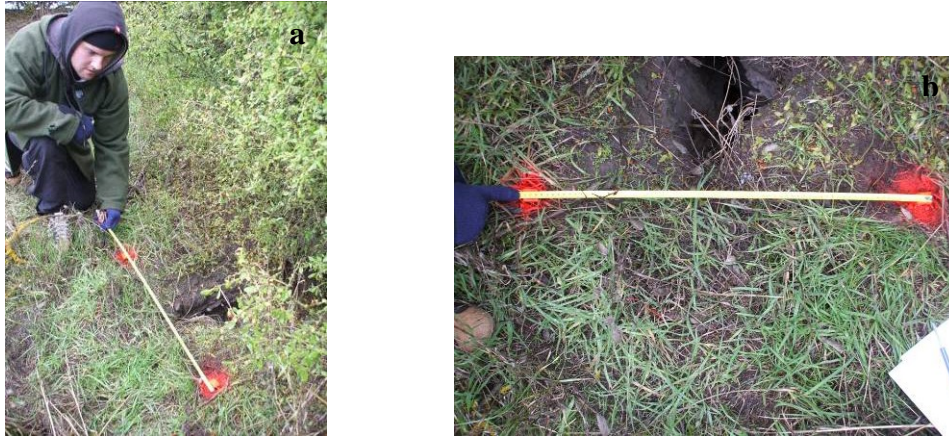
**Figure 5.26 a) measuring crack distance number 3 after stakes had been installed. b) Measurement was taken from the outside edge of the stakes. Photograph was taken 29<sup>th</sup> June 2009 beginning of study period.**

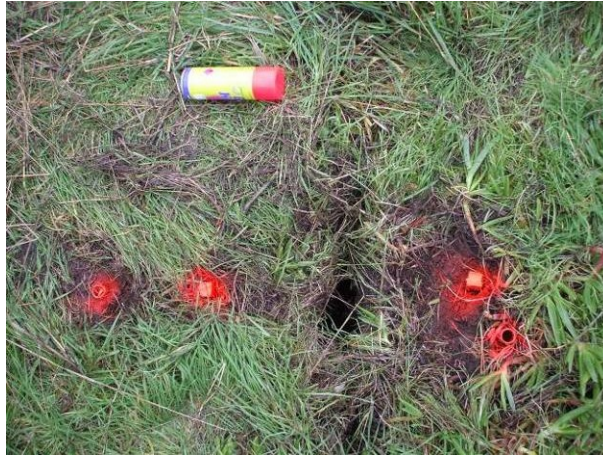
**Figure 5.27 Location of Barrell's (1989) small steel tube pegs. The existence of such pegs gives a rough indication of the age of this crack and the rate of movement. Photograph taken in late June 2009.**

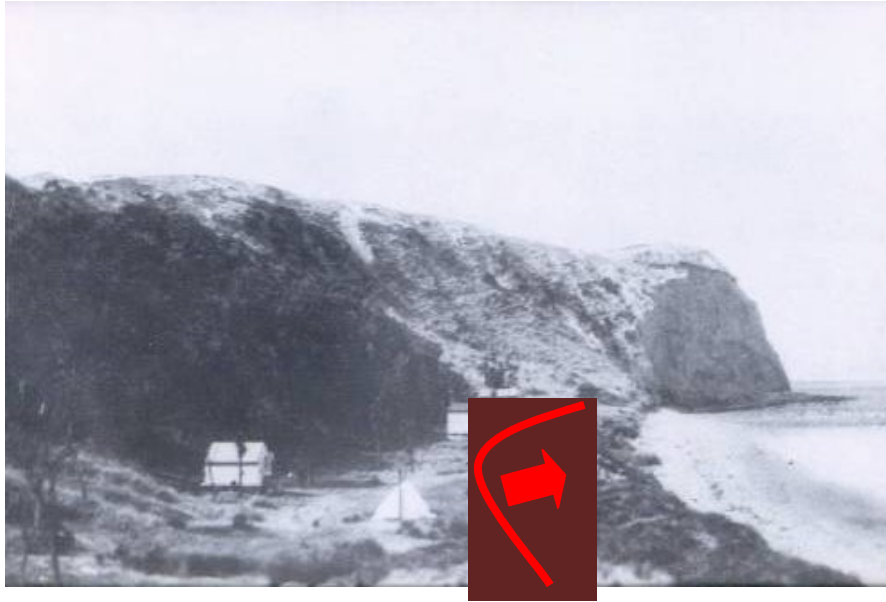
**Figure 6.2 Location of possible younger phase of sand dune accumulation. Photograph taken in 1950, sourced from Simon Foster, 2009.**

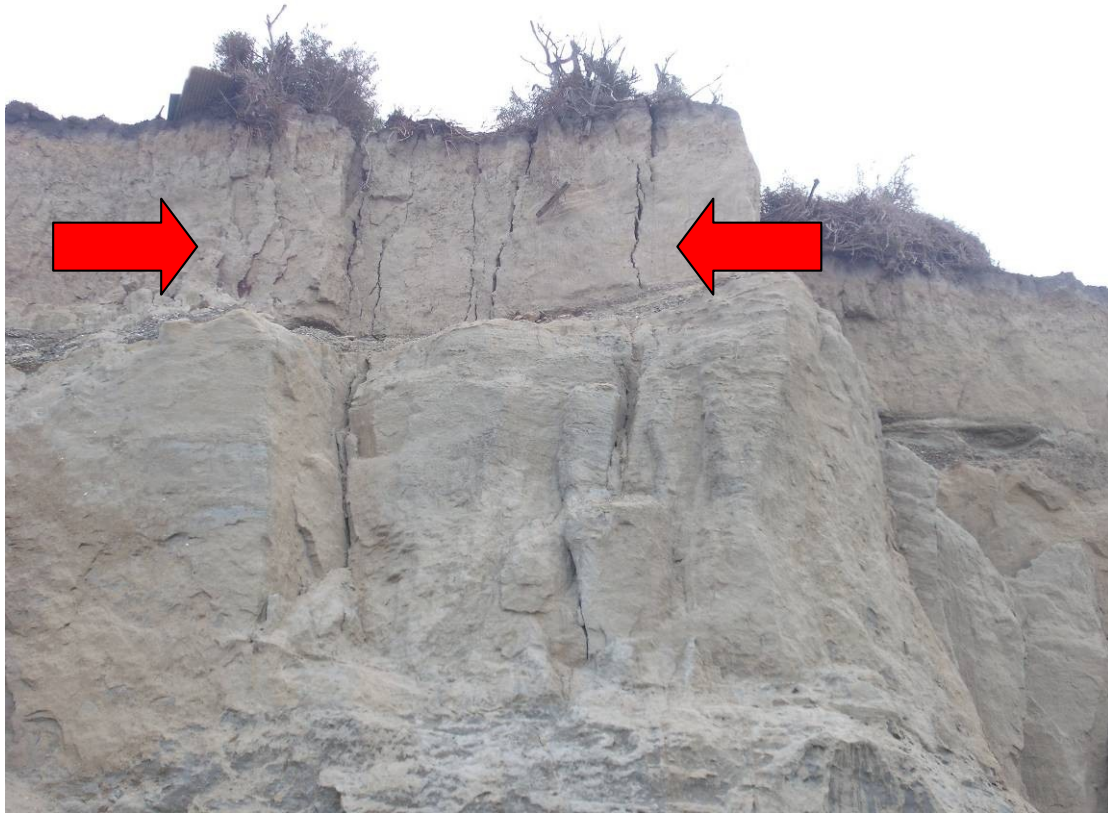
**Figure 6.5** Subaerial weathering of the cliff at Motunau Beach resulting in numerous tension cracks forming. Note the way in which the top section is degrading at a noticeably faster rate than the more consolidated material below. Also note the way in which the top section appears to be leaning seaward (photograph taken 13/1/2010).

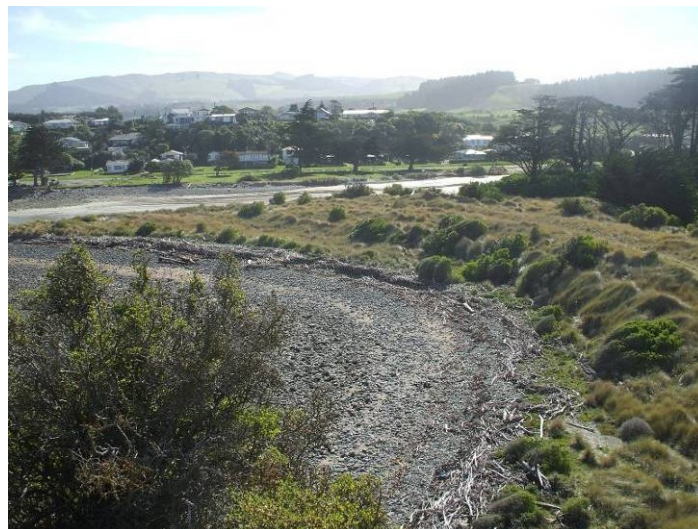
**Figure 6.7 The historic sand dune system on the seaward side of the Motunau River mouth. Photograph taken 22<sup>nd</sup> August 2009.**

Eddies or small localised circulations of water around the Motunau promontory could be one explanation for the deposits of sandy material around the Motunau River mouth (Figure 6.6). This historical deposit is in the lee of the eroding cliffs and rock shore platform (Figure 6.7), both of which protrude into the path of the littoral sediment transport. Sediment accumulates either side of such protrusions (Anthony, 2002). This supports the assumption that historically the eastern end of Sandy Bay did favour the accumulation of sediments prior to the increased rate of coastal erosion during the 1950s. This deposition potentially formed in conjunction with the sediment accumulations on Sandy Bay. Indicating that there is a link between the sheltering effects of the cliff headland and sand beach vulnerability. Figure 6.6 is based on examples from the literature of the effects protrusions have on sediment transport. At Motunau Beach historical deposits of sand are being eroded. The processes that deposited this sand have potentially changed as a result of continual erosion over the last 5,000 years. When the cliff headland protruded further seaward it would have favoured the formation of small current-eddies that deposited sands at the mouth of the Motunau River. As the cliffs have retreated these eddies have been dissipated by wave action which has resulted in increasing bed turbulence. This has resulted in the removal of material from the shoreline, altering the form of the nearshore bathymetry.
